# MASS WASTING in coastal Alaska

Douglas N. Swanston

U. S. D. A. FOREST SERVICE RESEARCH PAPER PNW-83  
1969

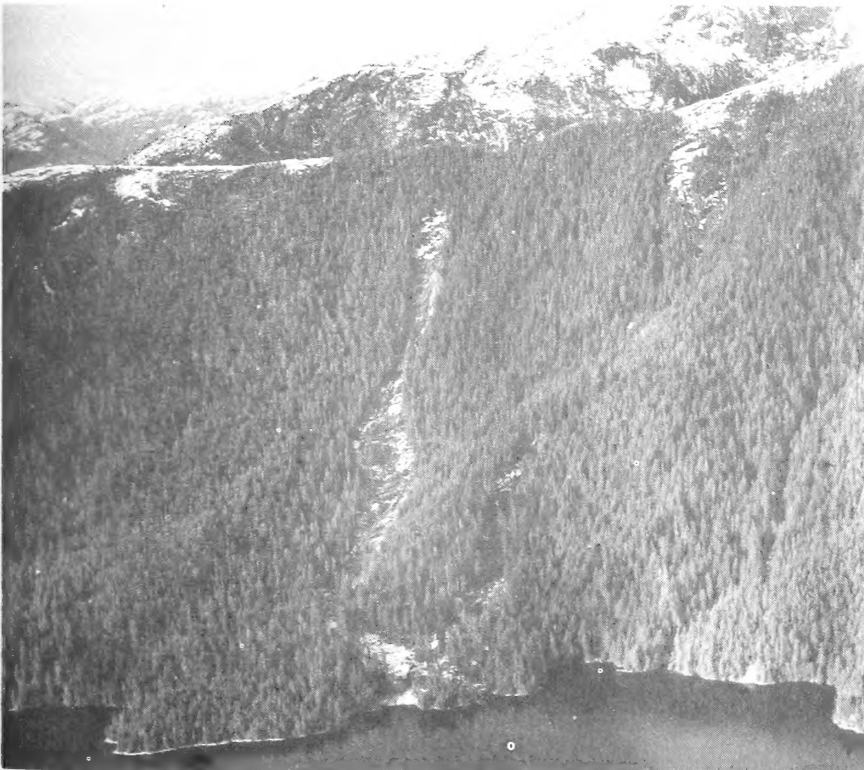
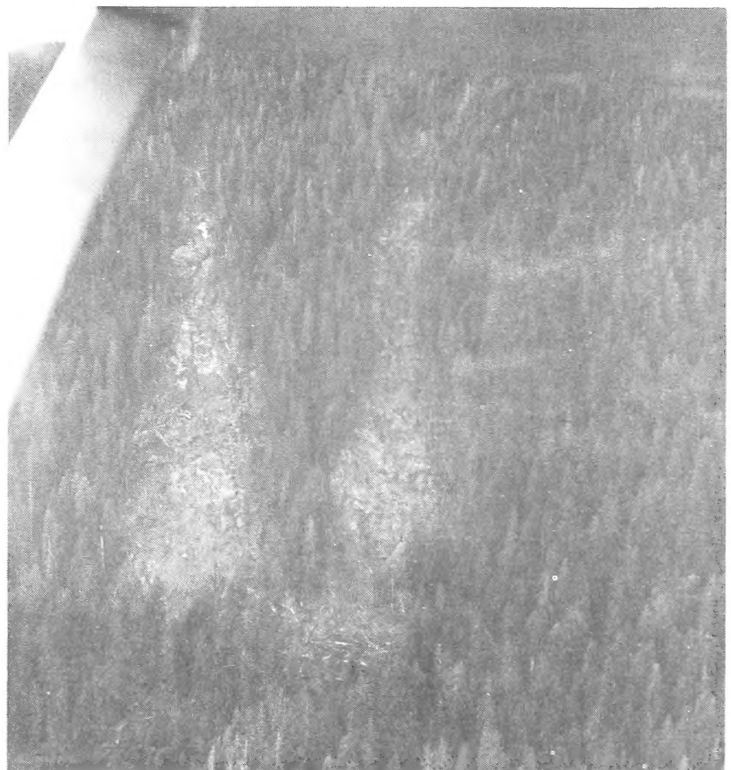
Figure 1.—Aerial views of recent debris avalanche-debris flow combinations on oversteepened slopes of southeast Alaska. A, Slide near Walker Cove, Behm Canal. A debris avalanche was apparently initiated by a rockfall from bluff directly above head of slide trace. Resultant debris flow lower on the slope carried debris directly to the sea. B, Two recent slides near Mirror Lake, Thorne Arm. In this case, much of the debris from the resultant flow has accumulated near the lower end of the slide trace.

The most recent debris avalanches and debris flows are clearly identified by bare linear strips on valley sideslopes and in deep V-notch channels where soil and vegetation have been removed (fig. 1). Increasingly older avalanche and flow scars are identified successively by strips of pioneering species such as willow (*Salix* spp.) and alder (*Alnus* spp.) and finally by even-age stands of Sitka spruce (*Picea sitchensis* (Bong.) Carr.) which are younger than the surrounding timber (figs. 2 and 3). Such

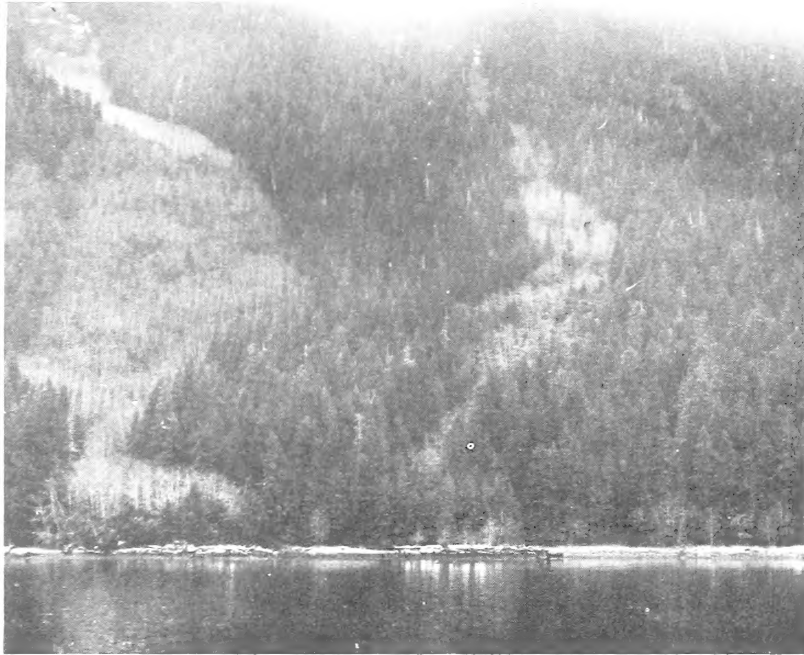
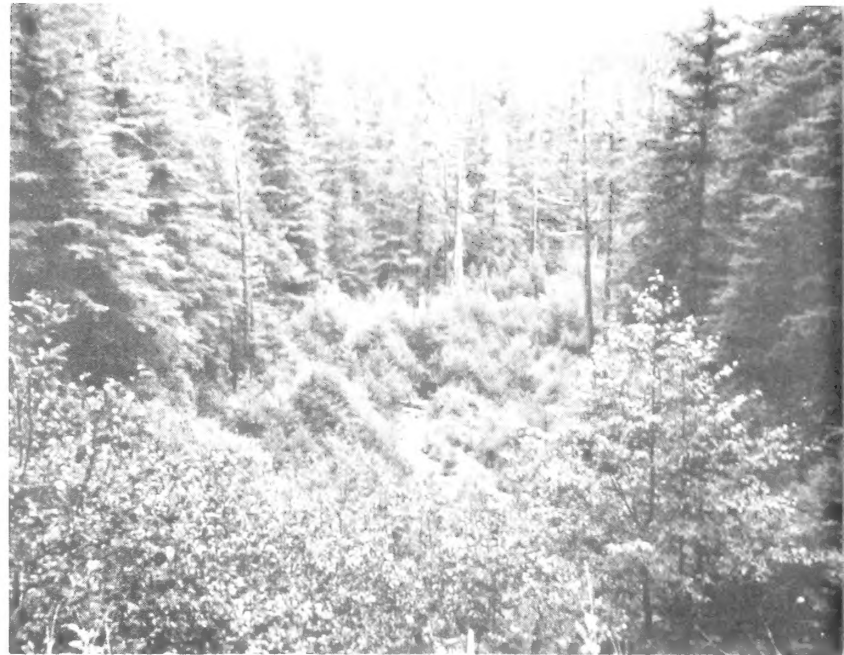
Figure 2.—Older debris avalanche-debris flow traces showing successional regrowth of willow, alder, and Sitka spruce. A, Aerial view of two slide traces revegetated by alder near the head of Walter Island Arm, Port Houghton. B, View of lower slide trace on the south side of Blake Channel Narrows. Note successional regrowth starting with willow and alder in the foreground with spruce moving in behind.

successional regrowth on the older slide traces is easily recognized on aerial photos and provides a convenient means of estimating present stability and past sliding history of a slope. Snow avalanches which produce similar linear tracks on timbered slopes can be differentiated and eliminated from these estimates by observation of the following characteristics. If the track origin lies below the upper timbered boundary, it is probably a debris avalanche track. If the track extends above the timber boundary, it probably originated as a snow avalanche. Also, a snow avalanche produces little soil deposition at the slope base, and there is little or no soil removal in the slide track.

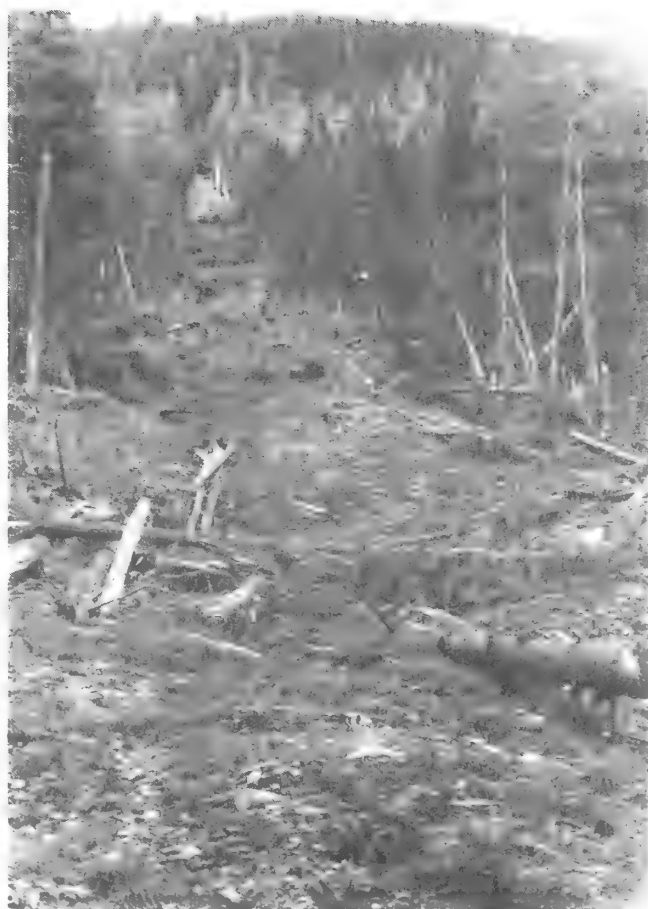
Figure 5.—Combination debris avalanche-debris flows developed in bedrock-derived soil (Tolstoi). A, Martin Creek valley, Bradfield Canal. View toward valley floor from center of slide trace, showing extensive debris flow deposit at base of slope which has broken through the trees at several points to deposit broken timber and other debris in small muskegs beyond. Note shallowness of soil typical of this type of landslide. Glacially rounded dioritic bedrock is exposed by complete removal of the soil layer in the slide trace. B, Maybeso Creek valley. Slide initiated by rockfall from bluff above slide head.

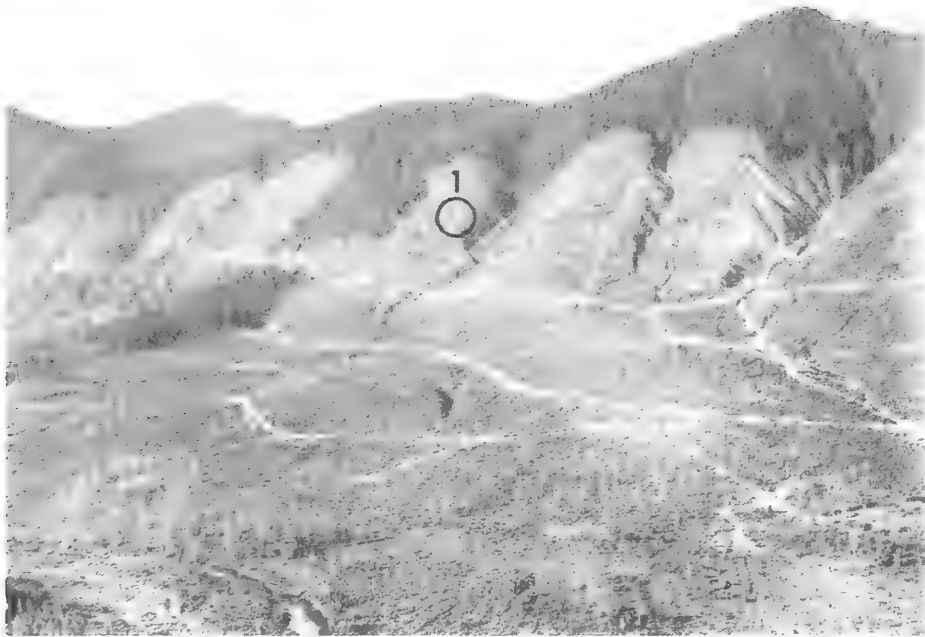
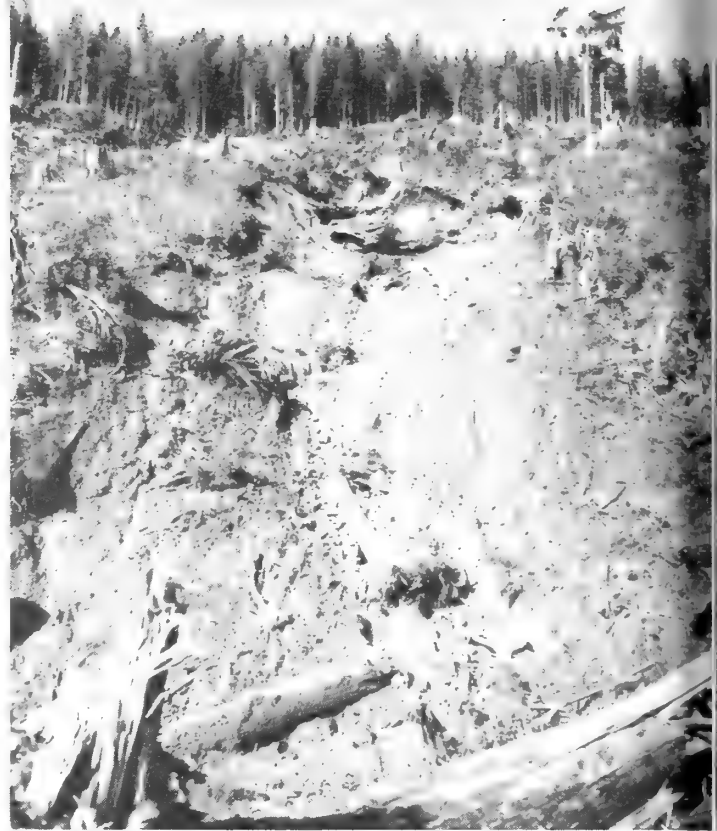
Figure 7.—Combination debris avalanche-debris flows in a glacial till soil (Karta), Maybeso Creek valley, Prince of Wales Island. **A**, Aerial view of dissected till-covered slope where active sliding is occurring. Recent sliding, directly correlated with a period of high rainfall and resultant concentration of soil water, has occurred to the right of the leave strip in the center of the photo (1). These are probably associated with clearcutting, but there is also much evidence of prelogging slide occurrence. **B**, Closeup view of slide at site 1. Note the shallowness of the slide trace. The unweathered till which served as the sliding surface is exposed in center foreground as a lighter soil zone next to the long-butted stump. The weathered till or Karta soil is the darker material above it.

Debris avalanches and debris flows in glacial till soils on valley sideslopes frequently begin within linear seepage depressions that dissect the till deposits (fig. 7). These depressions were originally formed as consequent drainage channels<sup>7/</sup> by surface runoff after retreat of glacier ice from the valleys. Since glacier retreat, a shallow podzol soil has developed in the channels and on the surrounding till slopes. At present, the soil in the depressions serves as a center of concentration for soil-water seepage. Surface runoff occurs in the depressions only during periods of extremely high rainfall when the till soil becomes saturated. The occurrence of buried soils, overturned profiles, and buried organic lenses in the lower end of these depressions indicates a past history of active sliding and suggests that, at present, the depressions enlarge themselves chiefly in this manner.

The debris avalanches begin in shallow soils developed in colluvium or glacial till. The slope gradients involved are far greater than the angle of internal friction of the particular soil, greatly intensifying any factors tending to reduce stability. The slopes are extremely unstable and on the verge of failure at all times. Downslope stress on the soil is increased due to the weight of added water during periods of high rainfall. Increased pore-water pressure or destruction of stabilizing root systems aggravates the condition and may initiate sliding, as may bank undercutting near a stream. Usually these slides have short runs, beginning at the tops of valley sideslopes and ending at the streams (figs. 7 and 8).

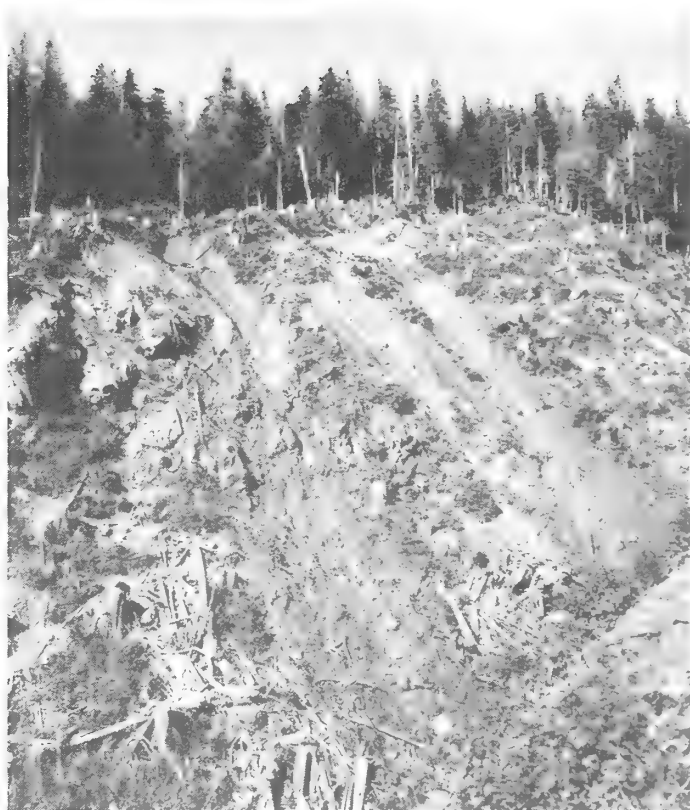
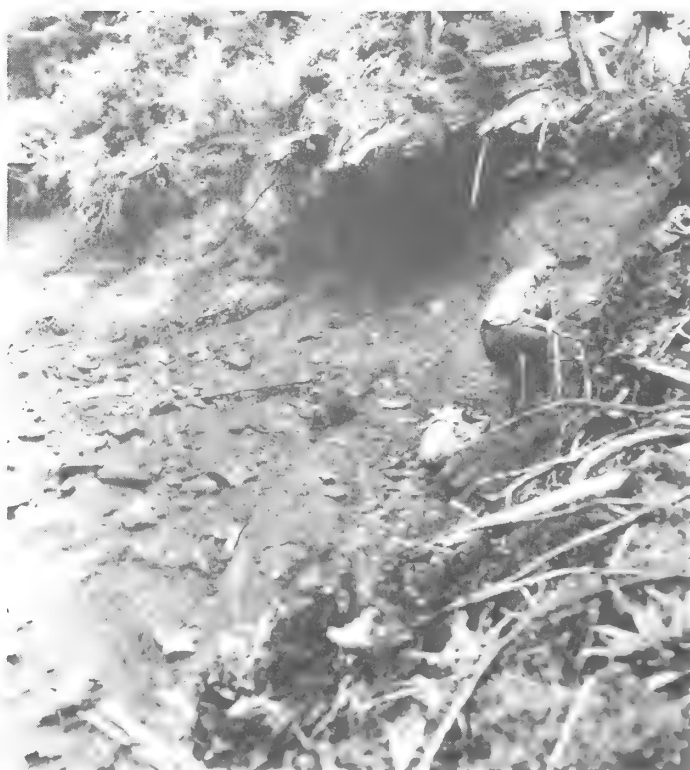
Figure 8.—Debris avalanches in steep-walled V-notch drainages. **A**, In till soil, Maybeso Creek valley. **B**, In bedrock-derived soil, Neets Bay. Note the masses of small roots overhanging the headwall of the slide. Many still remain firmly attached to the fractured and jointed bedrock substrata.

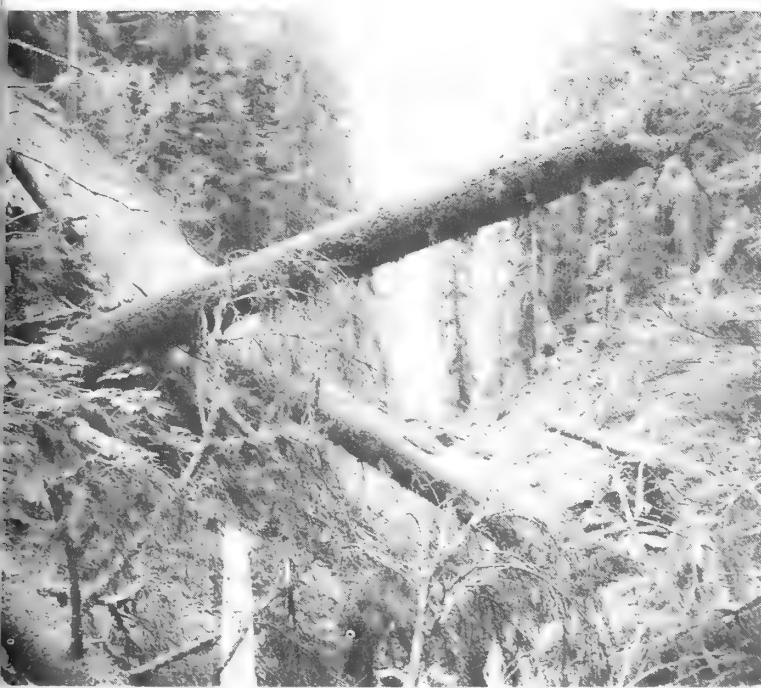
**Figure 9.**—Natural dam across V-notch drainage produced by accumulation of forest debris. Upstream debris-avalanching produces a buildup of soil and organic debris behind the dam which, when released, produces a large-scale debris torrent.

If the amounts of material are sufficient, they may become debris flows upon reaching the streams as a result of increased water content. More frequently, the debris is simply carried away as increased sediment load in the stream. Rapp (1961) in Scandinavia and Bishop and Stevens (1964) in southeast Alaska describe a phenomenon associated with this kind of flow resulting from debris avalanche accumulations in the bottoms of steep-sided channels. Debris forms a dam across a stream at the base of an avalanche. Subsequent material from upstream avalanches accumulates behind this barricade (fig. 9). When the dam gives way, a large volume debris flow or debris torrent occurs (fig. 10).
